**Report on the preliminary  
fact finding mission  
following the accident at the  
nuclear fuel processing  
facility in Tokaimura, Japan**

INTERNATIONAL ATOMIC ENERGY AGENCY, VIENNA, 1999

REPORT ON THE PRELIMINARY  
FACT FINDING MISSION  
FOLLOWING THE ACCIDENT AT THE  
NUCLEAR FUEL PROCESSING FACILITY  
IN TOKAIMURA, JAPAN

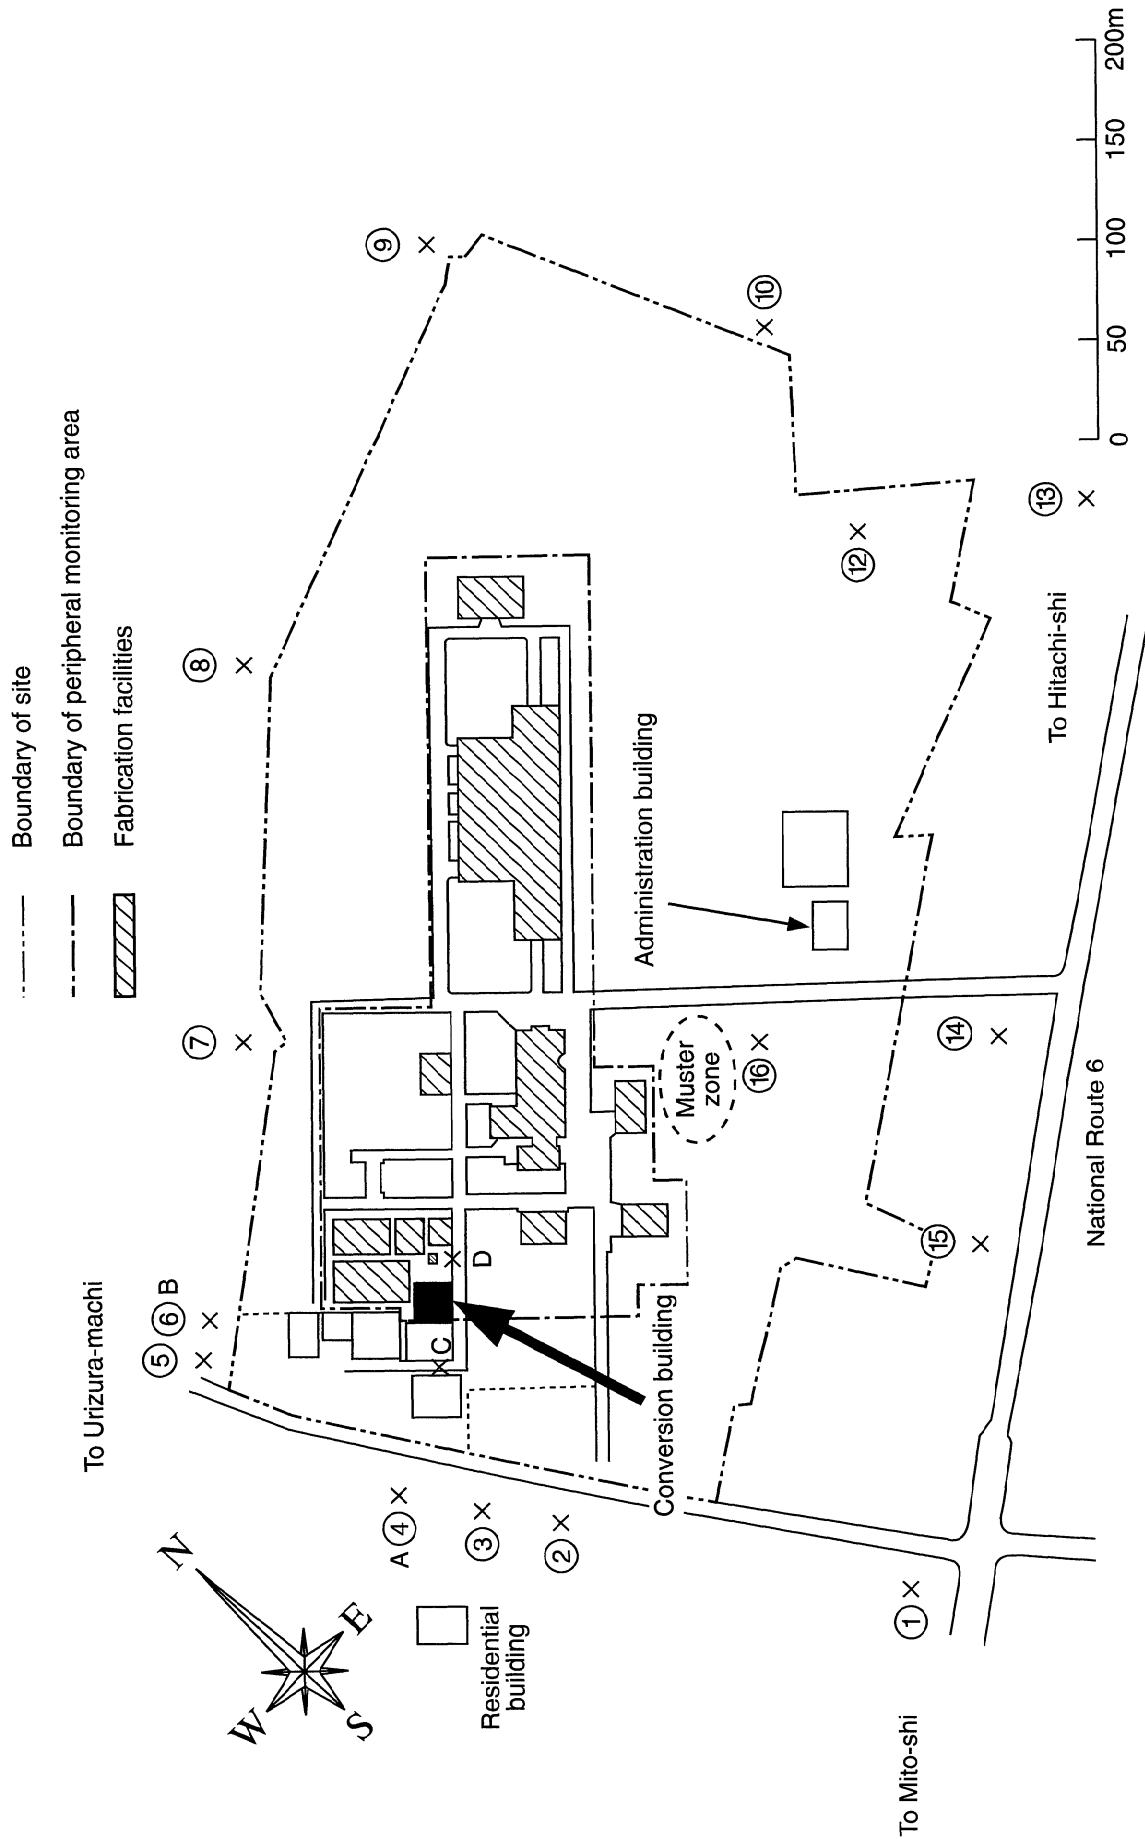
Fig. 4. Plan of the JCO site with location of monitoring points (circled numbers).

The criticality in the precipitation tank in the conversion building is considered to have continued for about 20 hours, from 10:35 on 30 September to about 06:30 on 1 October. In this period, the neutron dose rates at the site boundary (Fig. 4), measured at point A (about 90 m southwest of the conversion building) and point B (about 110 m northwest of the conversion building) fell from 4.0 and 4.5 mSv/h at the start of measurement at these locations (19:09–19:22 on 30 September) to below the detection limit when the criticality ceased. Gamma radiation dose rates decreased over time from the first gamma measurement between 11:35 and 11:50 on 30 September recorded at point A (0.84 mSv/h) to 0.001 mSv/h when criticality ceased. The neutron dose rates at around 20:45 on 30 September were found to decrease steadily with distance from the conversion building. The neutron dose rate decreased from about 3 mSv/h at 100 m from the JCO site to about 0.02 mSv/h at 500 m, a factor of about 100. The reduction factor with

Once criticality had ceased, neutron dose rates fell below the detection limit and gamma dose rates decreased to almost normal levels after sandbags were piled around the conversion building on 2 October. The IAEA Secretariat team's measurements of the gamma dose rate confirmed that levels were normal outside the JCO site boundary and dose rates on the site were slightly higher [29], e.g. 0.84  $\mu\text{Sv/h}$  at about 12 m east-northeast of the conversion building (point D), with no concrete blocks or sandbags along the line-of-sight between the detector and the conversion building (Fig. 4).
